# **Inspection Report**

## **Best Client**

**Property Address:**  
123 Sample St  
Baton Rouge LA 70810

## **At Ease Home Inspections LLC**

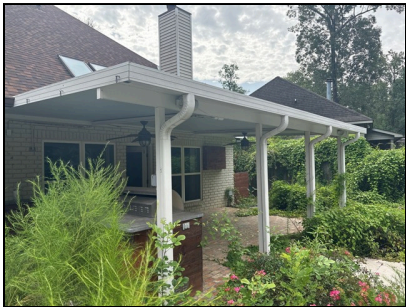
1.0 Item 1(Picture)

(1) I could not determine if the metal patio covers leak. **I suggest checking for leaks during the next rain and repairing if needed.**

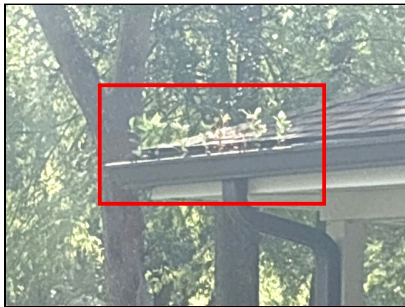
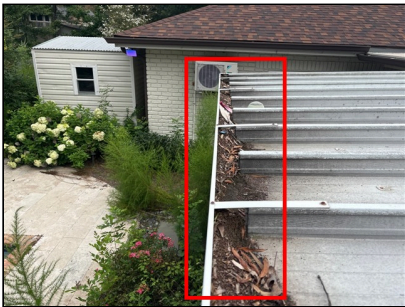
1.3 Item 1(Picture)

The gutters are full of debris in areas and need to be cleaned. The debris in gutters can also conceal rust, deterioration or leaks that are not visible until cleaned. I was unable to determine if these conditions exist, repair as needed.

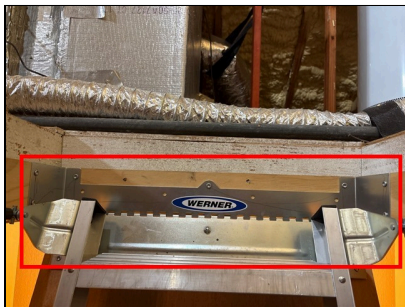
1.4 Item 1(Picture)

The pull-down attic stair needs steel lag screws and or 16D nails installed at hinge-mounts per manufacturers recommendations. The stairs are currently installed with framing nails which do not have the shear strength for this purpose. **Injury could result if not repaired. Repair or replace by a qualified person.**

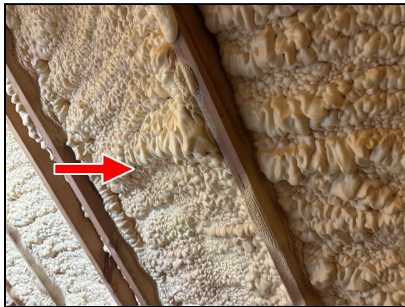
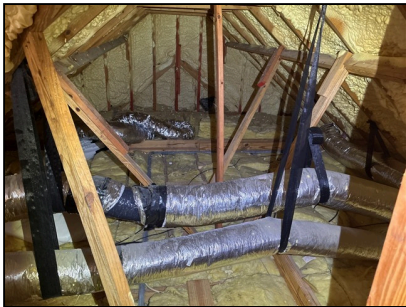
1.5 Item 1(Picture)

This house has spray foam insulation installed at the roof line. Today's standard requires that the roof rafters be encapsulated with the spray foam, any fiberglass batt insulation at the ceiling level should be removed, and gas-fired appliances should not be located in the encapsulated attic space. The improperly installed spray foam appears to be causing higher than normal humidity levels in the attic. **I recommend a licensed HVAC technician examine this attic space and install a dehumidifier.**

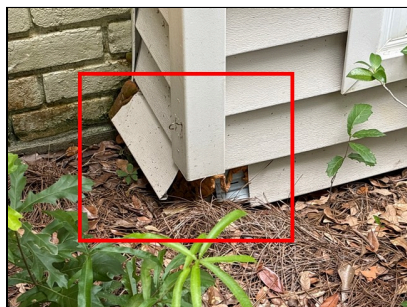
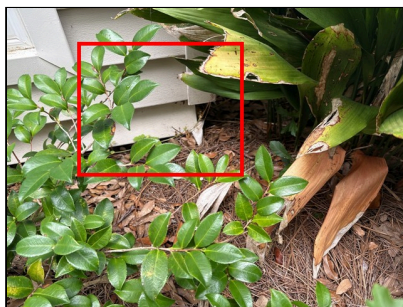
2.0 Item 3(Picture)

(3) The vinyl siding is loose/detached in one or more areas near the foundation at the front of the home. This area has been filled with spray foam. Repair as needed.

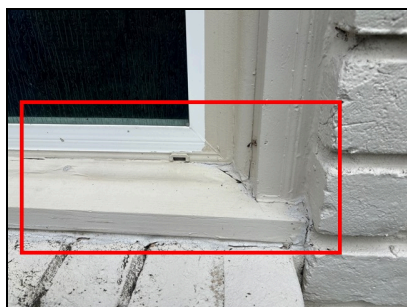
2.0 Item 5(Picture)

(4) There is some deterioration present on the exterior wood in one or more places. This is considered a normal maintenance item and should be repaired or replaced as needed.

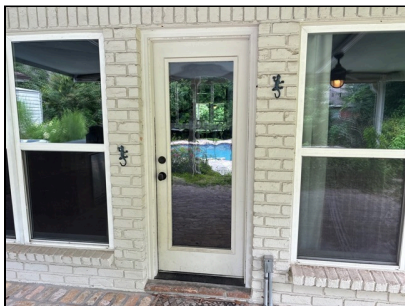
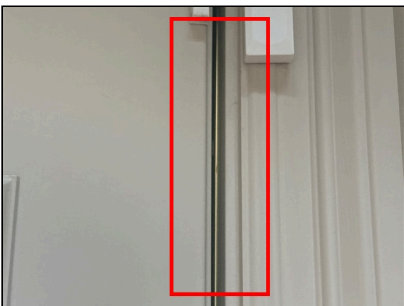
2.1 Item 6(Picture)

(3) The rear entry door reveals daylight at the weather-stripping and/or threshold when closed. Repair as needed.

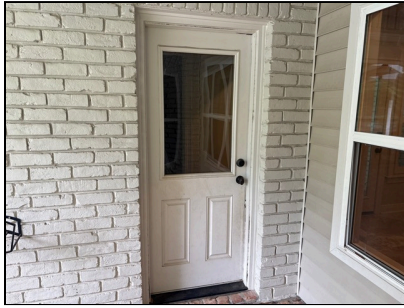
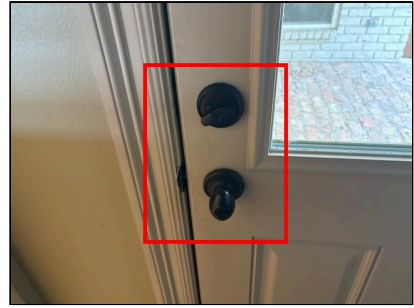
2.1 Item 9(Picture)

(4) The entry door from the hallway to the back patio reveals daylight at the weatherstripping and/or threshold when closed. The door does not latch at the handle set, but will secure with the deadbolt. Repair as needed.

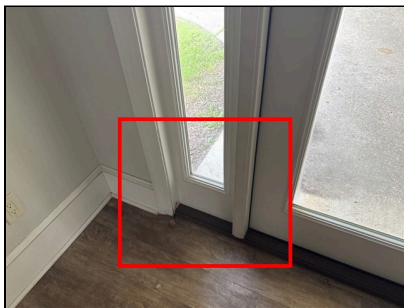
2.1 Item 14(Picture)

(6) There are signs of past moisture intrusion at the sidelight frame on the converted garage entry door. These areas were dry at the time of this inspection. **I recommend monitoring these areas for further damage and repairing as needed.**

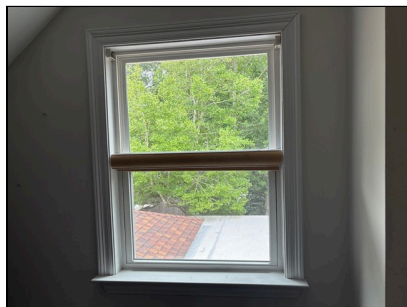
2.2 Item 1(Picture)

(1) One or more windows have been fixed so they will not open, this can be a safety concern if the windows are needed for emergency egress. Repair as needed.

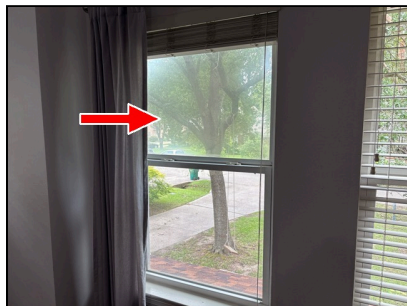
2.2 Item 2(Picture)

(2) There are one or more windows with the seals broken. This is where moisture gets between the panes and clouds the windows. This does not affect the moisture content into the dwelling but is cosmetic.

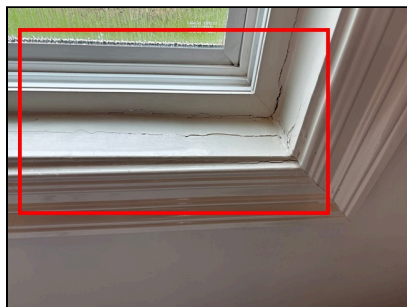
2.2 Item 3(Picture)

(3) One or more interior window sills have moisture damage. These were dry at the time of this inspection. Repair as needed.

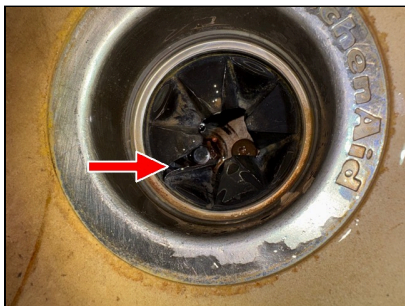
3.0 Item 10(Picture)

(4) The disposal worked as intended. The rubber splash guard is damaged. The electrical whip is installed without the use of a wire clamp. Repair as needed.

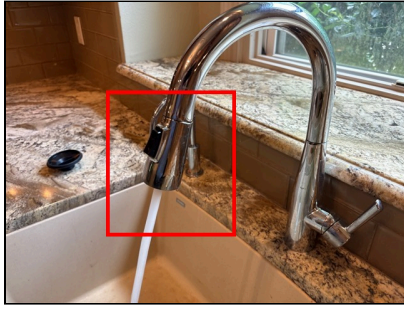
3.3 Item 1(Picture)

(1) The handheld sprayer at the kitchen sink faucet is damaged. Repair as needed.

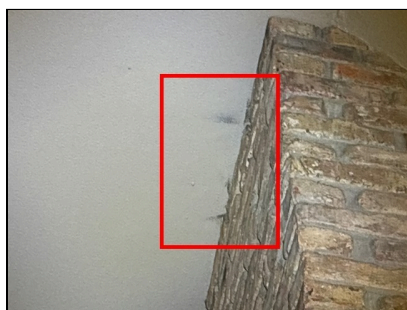
4.0 Item 1(Picture)

📍 (1) Microbial growth was noted in one or more places at the greatroom ceiling near the fireplace. Normally the underlying cause of this is moisture from attic air intrusion and/or higher than normal humid conditions. The growth can normally be rectified by preventing or stopping these conditions from existing and cleaning. If this is a concern to the client, we offer sample testing by a private testing laboratory for your convenience.

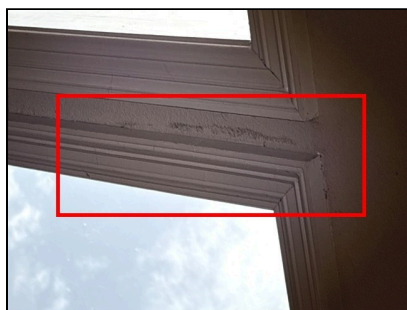
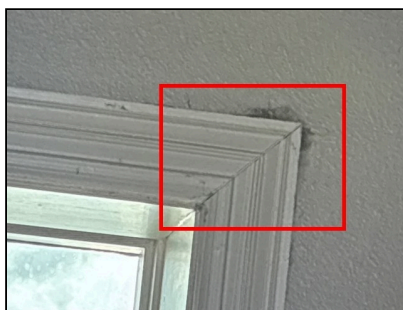
4.0 Item 2(Picture)

📍 (2) Microbial growth was noted in one or more places at the greatroom ceiling near the skylights. Normally the underlying cause of this from leaking around the skylight flashing. Possible leaks may have been fixed when the roof was replaced. The growth can normally be rectified by preventing or stopping these conditions from existing and cleaning. If this is a concern to the client, we offer sample testing by a private testing laboratory for your convenience.

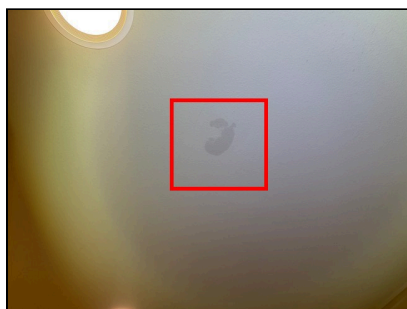
4.0 Item 4(Picture)

(3) The ceiling is stained in one or more places. It appears that the staining is old. Monitor for further staining and repair as needed.

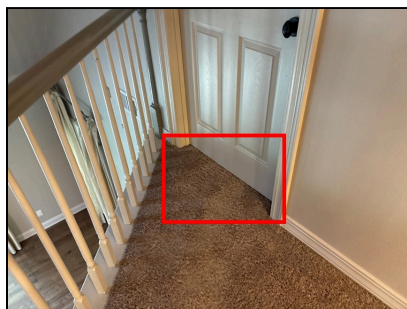
4.5 Item 1(Picture)

One or more interior doors are too close to the floor when closed and will not allow return air flow under the doors. An entry door to a room with an HVAC vent should have 1/2" to 3/4" inch of clearance under the door. Repair as needed.

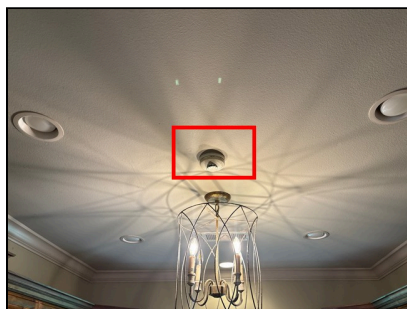
4.6 Item 2(Picture)

(2) There are one or more heat detectors in this home, these are normally installed on the alarm system and could not be checked. **I suggest checking these before occupancy to insure that they are working properly.**

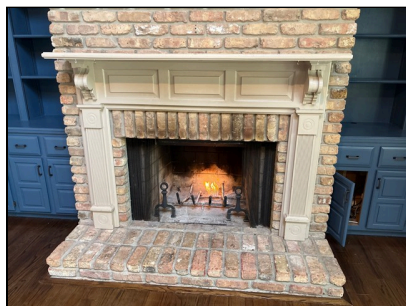
4.9 Item 1(Picture)

All fireplaces should be cleaned and inspected on a regular basis to make sure that no cracks have developed. Large fires in the firebox can overheat the firebox and flue liners, sometimes resulting in internal damage. Before the beginning of the wood burning season, all fireplace flues and flue lining should be inspected by a chimney professional. Fireplace flues and linings are not fully visible and are not included in the scope of this inspection. For safety we recommend installing a CO detector no closer than 15 feet from the fireplace. The ash needs to be cleaned out of the bottom of the firebox.

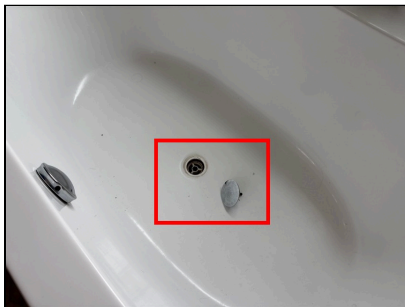
5.1.A Item 1(Picture)

The stop valve linkage and mechanism at the tub drain is loose and may be leaking under the tub. **Repair is needed by a licensed plumber.** Because the drain line is not connected properly the tub supply valves could not be tested.

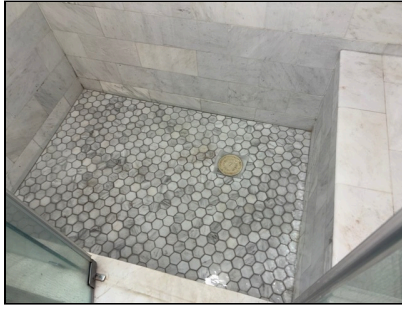
5.2.A Item 1(Picture)

The tile shower pan in the master bath was filled with water and let sit for 20 minutes. No leaks were observed at the time of this inspection. The shower drain is full of debris and needs to be

cleaned.

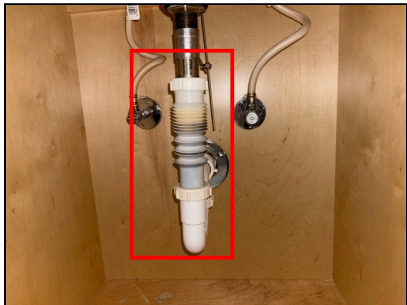
5.1.B Item 1(Picture)

There is corrugated piping used at the sink waste drain lines at the hall bath. This style of piping is prone to clogging faster than smooth bore piping. Repair as needed.

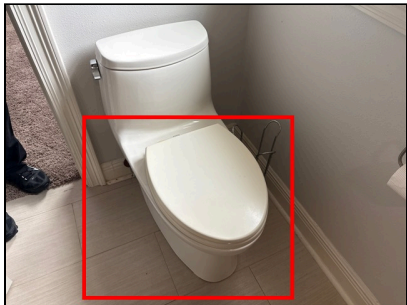
5.2.B Item 1(Picture)

The toilet is loose at the floor in the shared bath. Repairs may involve re-setting the toilet on a new wax seal or just re-tightening the nuts on the flange bolts. **I recommend a qualified licensed plumber repair or correct as needed.**

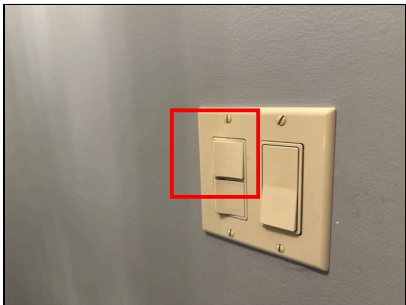
5.3.C Item 1(Picture)

The light switch for the vent in the half bath is damaged. **Repair is needed.**

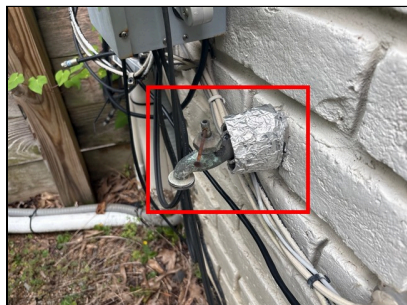
7.1 Item 1(Picture)

(1) One or more hose bibs have a damaged handle. Repair as needed.

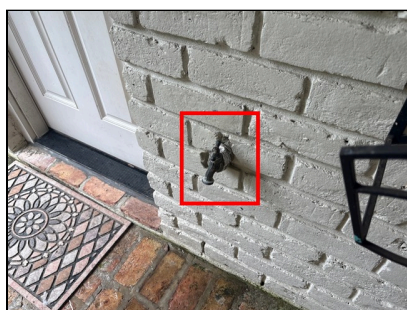
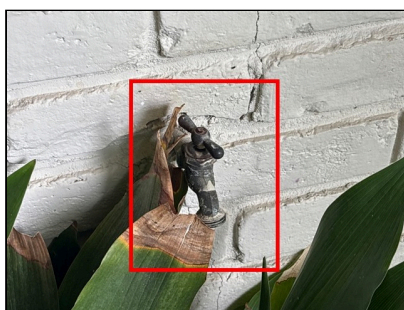
7.1 Item 2(Picture)

(2) One or more hose bibs leak from the valve stem when turned on. Repair as needed.

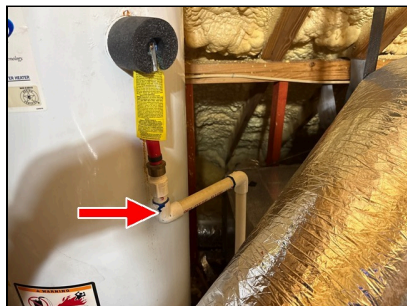
7.2 Item 1(Picture)

(1) The existing piping for T&P valve on water heater is PVC material (not allowed for hot water). Material must be Copper, Galvanized, CPVC, PEX or Poly. **Repair is needed**

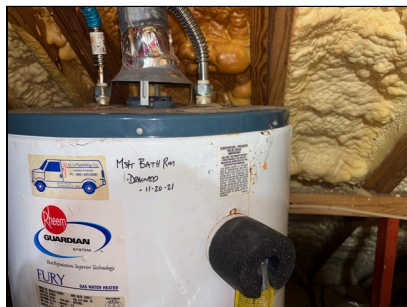
7.2 Item 2(Picture)

(2) There were signs of a past leak at the left side water heater. No leaks were observed at the time of inspection. Repair as needed.

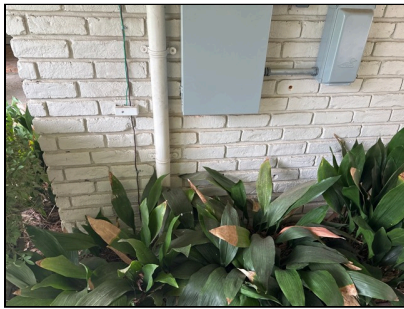
8.0 Item 2(Picture)

🔧 (2) I could not locate the ground rod at the electrical service entrance. The ground rod may not be present or could be buried. **I recommend an electrician verify the presence of a ground rod.**

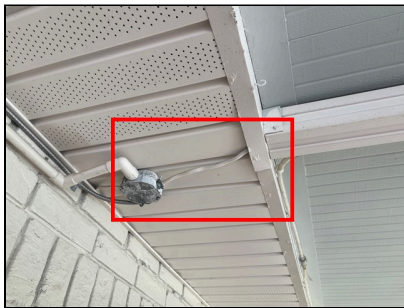
8.0 Item 6(Picture)

(6) There is exposed electrical wiring in one or more places at the exterior that is not in conduit. Repair as needed.

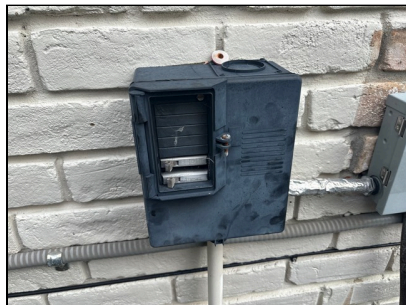
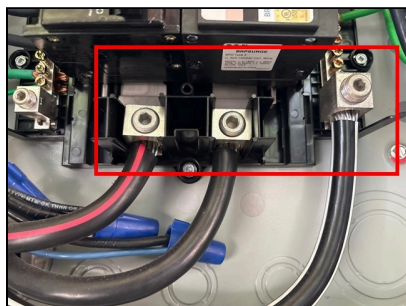
8.1 Item 1(Picture)

⚡ (1) The problem(s) discovered in the exterior main panel such as no dielectric grease on the aluminum wiring terminations, and any other problems that an electrician may discover while performing repairs need correcting. I recommend a licensed electrician inspect further and correct as needed.

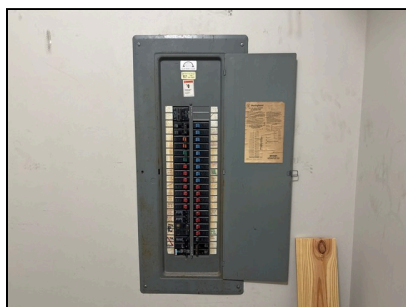
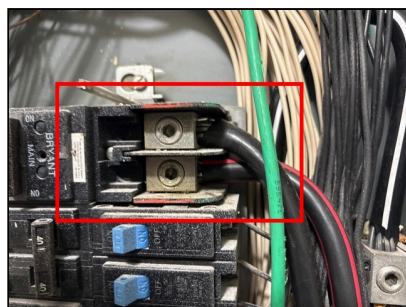
8.1 Item 5(Picture)

⚡ (2) The problems discovered in the panel such as circuits not labeled or identified, missing and/or wrong screws in panel cover, no dielectric grease on the aluminum wiring terminations, and any other problems that an electrician may discover while performing repairs need correcting. **I recommend a licensed electrician inspect further and correct as needed.**

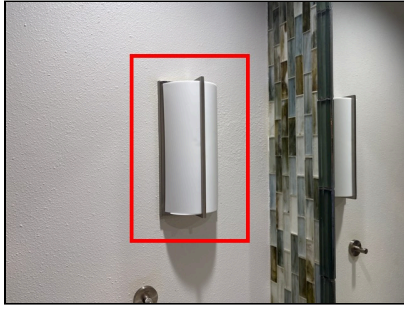
8.2 Item 1(Picture)

One or more light fixtures do not work. Check the bulbs. Repair as needed.

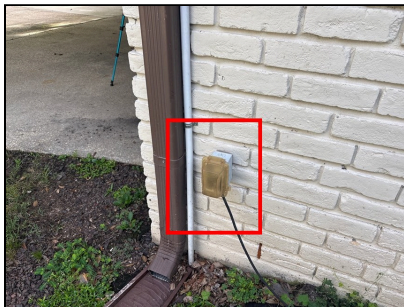
8.3 Item 1(Picture)

(1) The GFCI receptacle on the rear of the car port trips easily. **Repair is needed.**

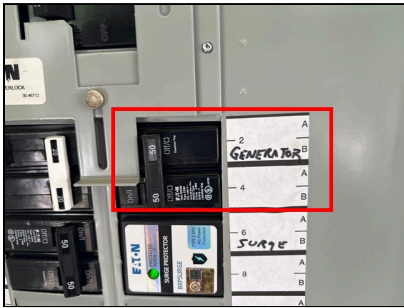
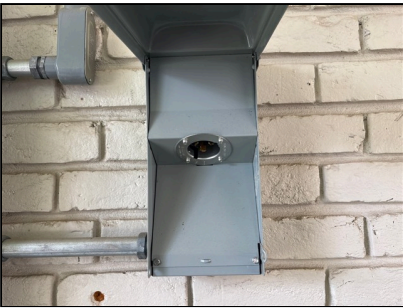
8.5 Item 1(Picture)

There is an installed back feed circuit for a portable generator near the exterior main panel. Portable generator should not be run within 20 feet of the home and never under an overhang or carport. I recommend the buyers educate themselves on the proper use of this circuit.

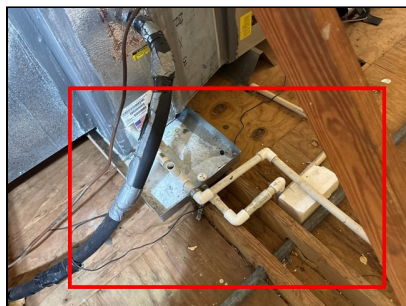
9.0.A Item 1(Picture)

(2) All or part of the insulation is missing on the evaporator coil drain line in the attic. Missing insulation can allow condensate to drip from the line. **Repair is needed.**

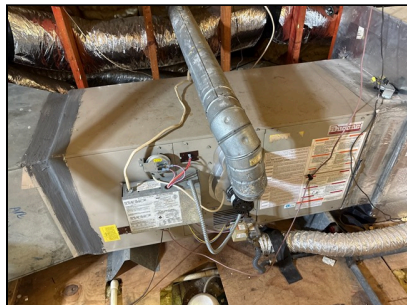
9.1.A Item 1(Picture)

**and burners require cleaning and reinspection by a licensed HVAC contractor to insure a leak proof heat exchanger.** Because of the age of the unit I suggest that this be completed every year until the unit is changed out. We are unable to determine the remaining life expectancy of the unit.

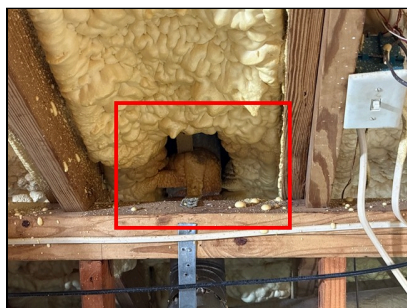
9.1.A Item 2(Picture)

(2) The heater vent pipe is touching combustibles at the roof. The vent pipe should have a minimum 3 inch clearance from any spray foam. **Repair or replace.**

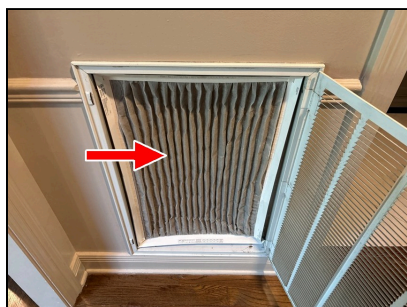
9.4.A Item 1(Picture)

The return air filter is dirty and **requires replacement.**

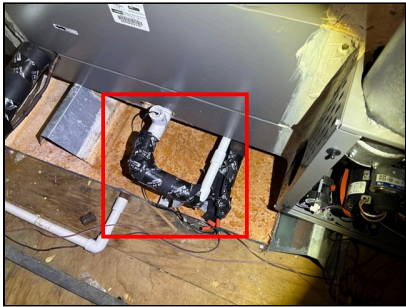
9.0.B Item 1(Picture)

(2) All or part of the insulation is missing on the evaporator coil drain line in the attic. Missing insulation can allow condensate to drip from the line. **Repair is needed.**

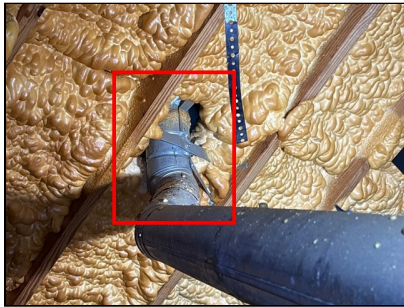
9.1.B Item 1(Picture)

The heater vent pipe is touching combustibles at the roof. The vent pipe should have a minimum 3 inch clearance from any spray foam. **Repair or replace.**

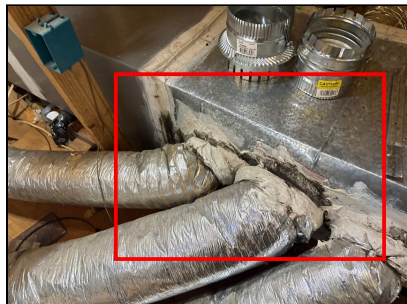
9.4.B Item 1(Picture)

(1) Microbial growth was noted in one or more places on the HVAC unit in the attic. The type of growth can not be determined by this inspection or if it is or is not a health hazard. Normally the underlying cause of this is moisture either from condensation and/or higher than normal humid conditions such as in the attic. Also this can be caused by not running HVAC equipment for a period of time. **The growth can normally be rectified by preventing or stopping these conditions from existing and cleaning.** If this is a concern to the client, we offer sample testing by a private testing laboratory for your convenience.

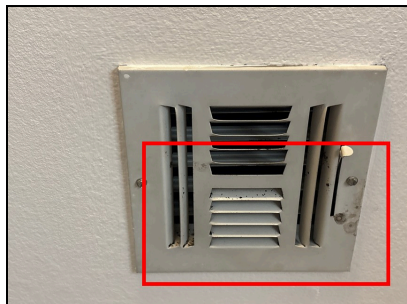
9.4.B Item 2(Picture)

(2) Microbial growth was noted around one or more HVAC registers. The type of growth can not be determined by this inspection or if it is or is not a health hazard. Normally the underlying cause of this is moisture either from condensation and/or higher than normal humid conditions such as air infiltration from the attic. Also this can be caused by not running HVAC equipment for a period of time. **The growth can normally be rectified by preventing or stopping these conditions from existing and cleaning.** If this is a concern to the client, we offer sample testing by a private testing laboratory for your convenience.

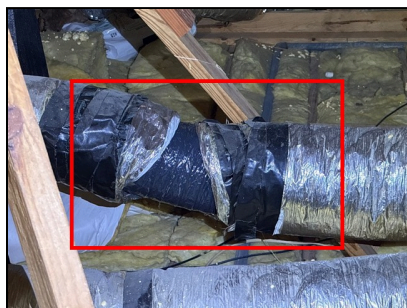
9.4.B Item 3(Picture)

(3) The HVAC ductwork has loose/missing insulation in one or more places and may be forming condensate on the piping causing higher than normal energy consumption. Repair as needed.

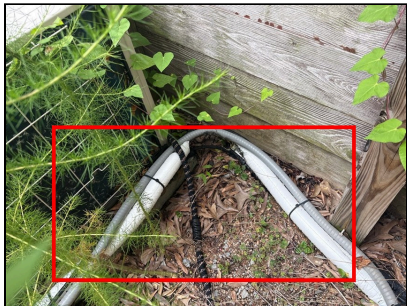
9.0.C Item 1(Picture)

The suction line on the outside condensing unit is missing insulation which will cause the line to drip condensate and cause energy loss. Repair as needed.

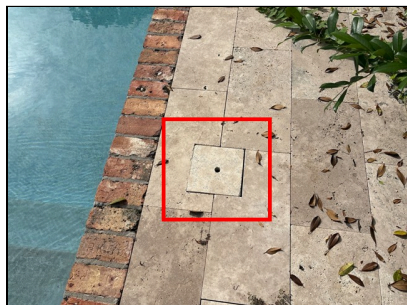
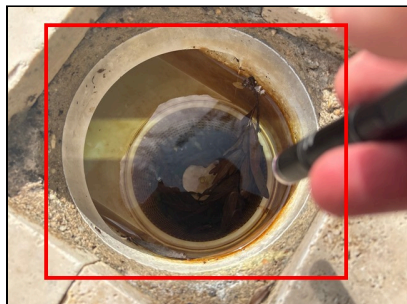
12.8 Item 1(Picture)

(1) There are two overflow skimmers at the rear of the pool. Both skimmer baskets were full of debris and were missing the lift handles. Repair as needed.

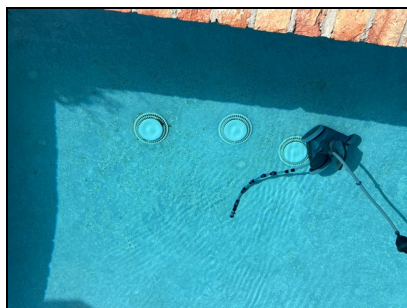
12.8 Item 5(Picture)

(2) There are three bottom drains installed in the pool. Newer constructed pools have multiple drains and safety vacuum release systems (SVRS), which help prevent drowning due to body entrapment on underwater drains. I could not verify the presence of an SVRS system. I recommend consulting with a licensed pool professional to verify if this system is installed.
