# **Inspection Report**

## **Best Client**

**Property Address:**  
123 Sample St  
Baton Rouge LA 70810

## **At Ease Home Inspections LLC**

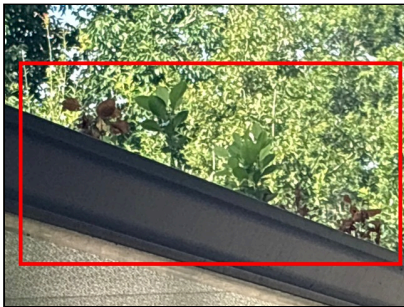
1.3 Item 2(Picture)

The gutters are full of debris in areas and need to be cleaned. The debris in gutters can also conceal rust, deterioration or leaks that are not visible until cleaned. I was unable to determine if these conditions exist, repair as needed.

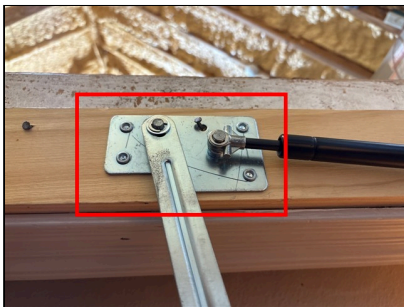
1.4 Item 2(Picture)

The pull-down attic stair needs steel lag screws and or 16D nails installed at hinge-mounts per manufacturers recommendations. The stairs are currently installed with framing nails which do not have the shear strength for this purpose. **Injury could result if not repaired. Repair or replace by a qualified person.**

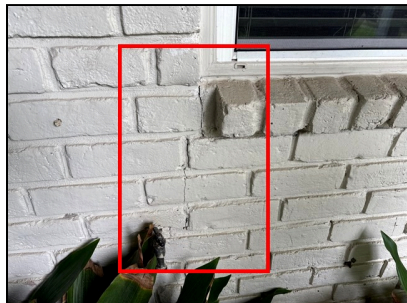
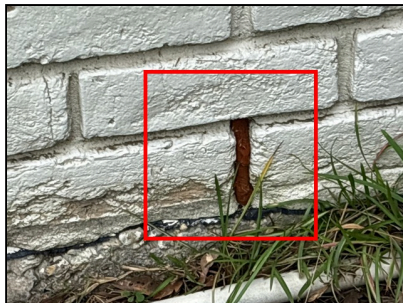
(1) It is common for bricks and the mortar between the bricks to crack from normal settlement in exterior areas of the building. I suggest sealing these areas to prevent moisture intrusion, periodic sealing may be necessary as a normal maintenance item. Any cracking beyond the normal expected amount will be noted in the structural section of this report. One or more weep holes have been sealed with spray foam.

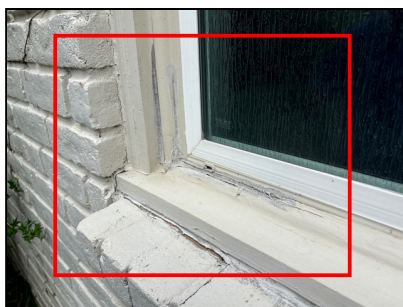
2.0 Item 6(Picture)

(4) There is some deterioration present on the exterior wood in one or more places. This is considered a normal maintenance item and should be repaired or replaced as needed.

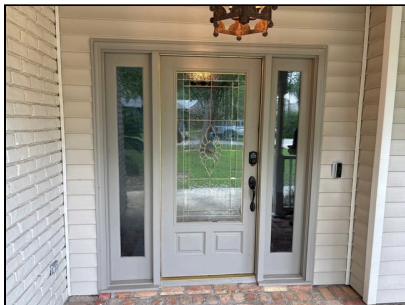
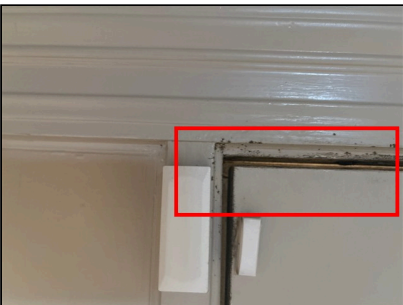
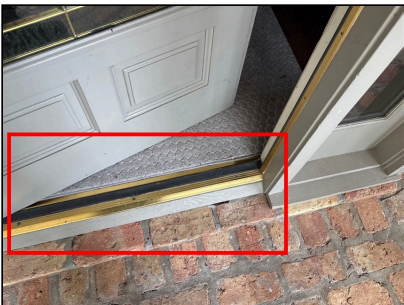
(1) The front entry door reveals daylight at the weather-stripping and/or threshold when closed. The door rubs at the threshold. Repair as needed.

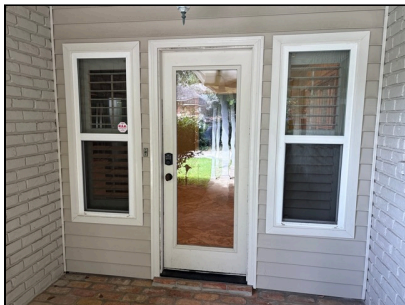
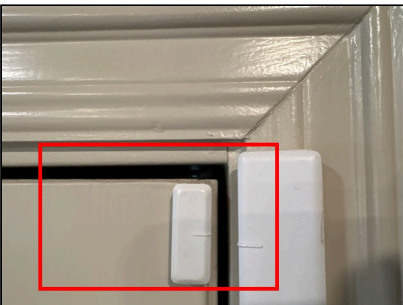
(2) The right side entry door revealed daylight at the weatherstripping and/or threshold when closed. Repair as needed.

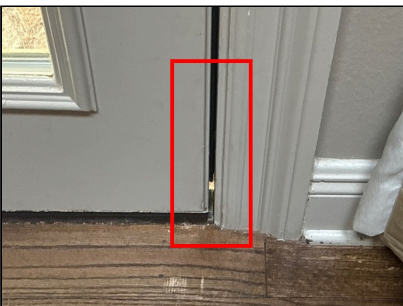
2.1 Item 7(Picture)

(3) The rear entry door reveals daylight at the weather-stripping and/or threshold when closed. Repair as needed.

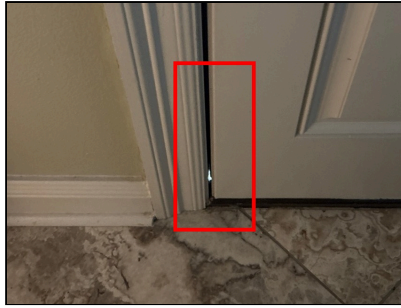
2.1 Item 10(Picture)

(4) The entry door from the hallway to the back patio reveals daylight at the weatherstripping and/or threshold when closed. The door does not latch at the handle set, but will secure with the deadbolt. Repair as needed.

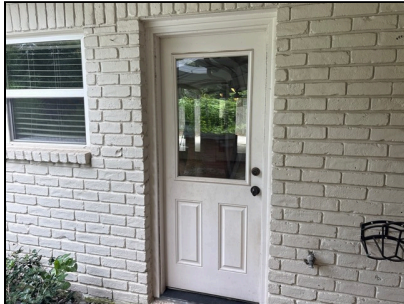
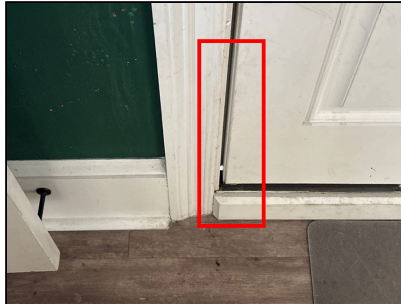
(5) Entry door from the back patio to the converted garage reveals daylight at the weatherstripping and/or threshold when closed. Repair as needed.

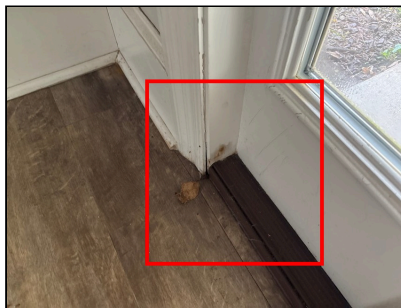
2.1 Item 15(Picture)

(6) There are signs of past moisture intrusion at the sidelight frame on the converted garage entry door. These areas were dry at the time of this inspection. **I recommend monitoring these areas for further damage and repairing as needed.**

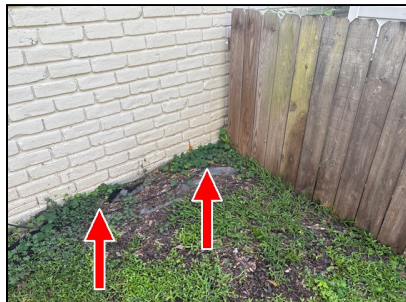
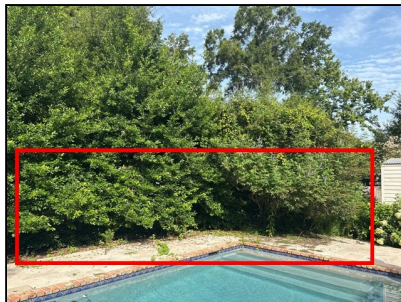
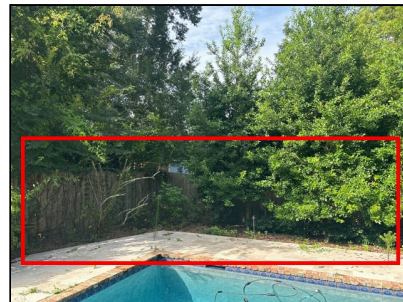
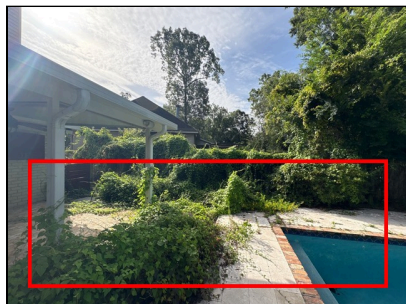
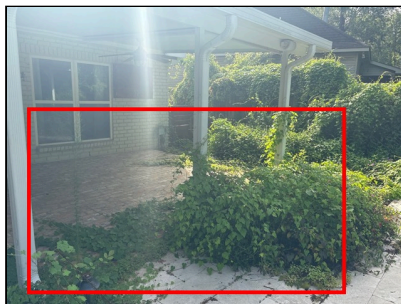
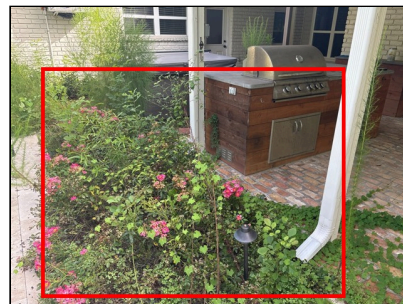
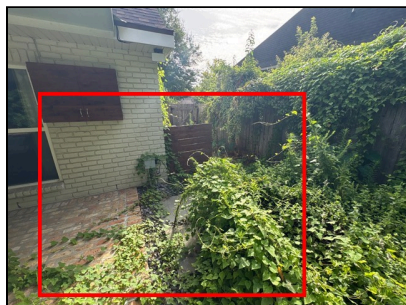
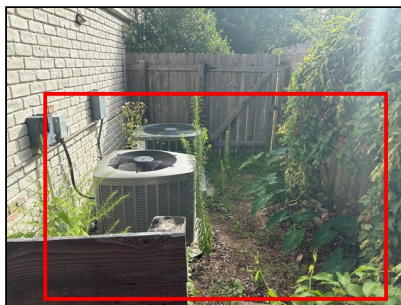
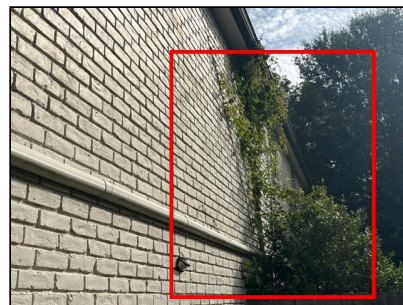
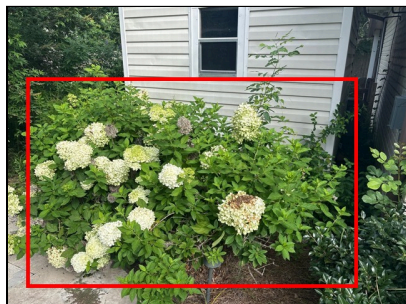
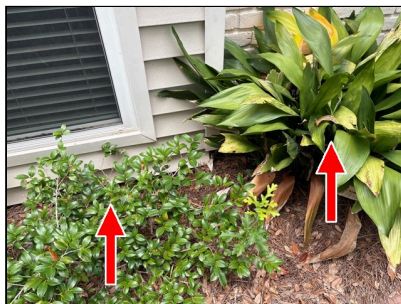
foundation is *visible* when *possible*, vegetation should be a **minimum** of 12 inches away from the building, both of these conditions help prevent pest, insect and moisture intrusion into the building. The flower beds should slope away from the structure to prevent moisture from entering the dwelling or standing next to the foundation wall. It can not be determined if any drainage systems around the house are working, I recommend having these drains cleaned and maintained to prevent moisture intrusion into the dwelling. The vegetation around the home and pool area are overgrown and need to be trimmed back.

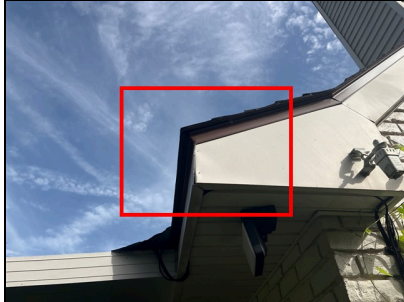
2.5 Item 1(Picture)

The metal fascia covering is loose/detached in one or more areas. Repair as needed.

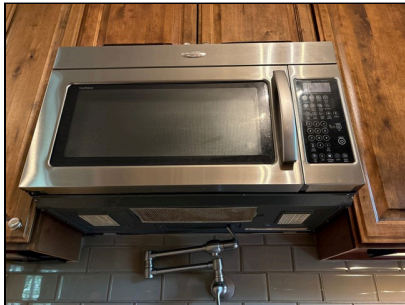
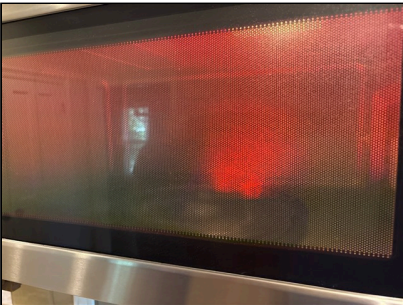
(2) The recirculating microwave vent hood worked as intended. The surface lights did not work. Check the bulbs. Repair as needed. By today's standards and kitchen ventilation over a gas

range should vent to the exterior of the home.

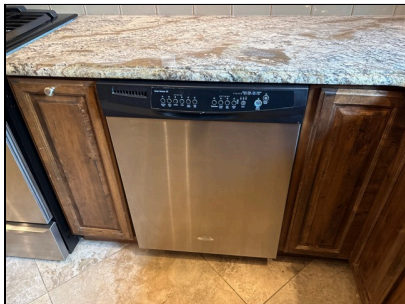
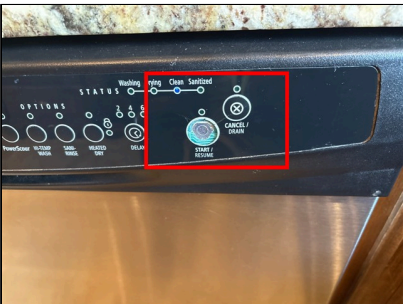
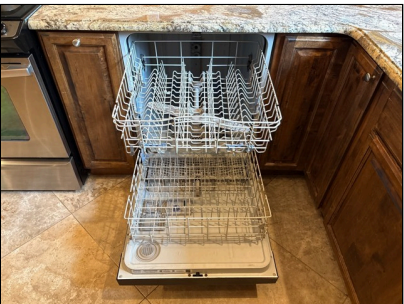
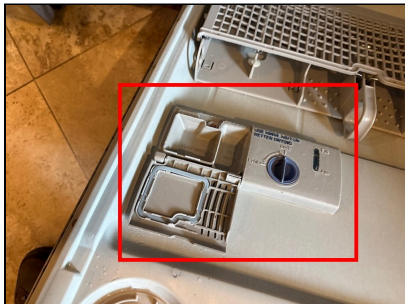
(3) The dishwasher was run through a short cycle. The unit ran and drained as intended. The buttons on the control panel are damaged and the dishwasher is not secured to the countertop. The soap dispenser does not latch closed. Repair as needed.

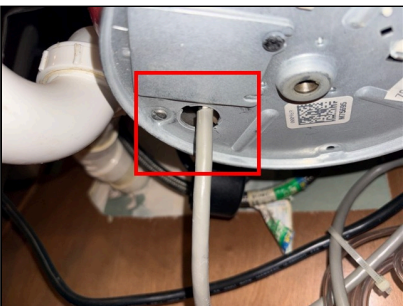
3.0 Item 11(Picture)

(4) The disposal worked as intended. The rubber splash guard is damaged. The electrical whip is installed without the use of a wire clamp. Repair as needed.

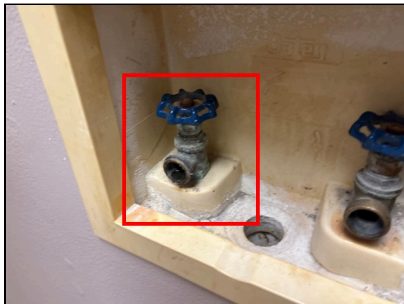
3.1 Item 1(Picture)

(1) The hot water valve at the washer box leaks when turned off. **Repair is needed.**

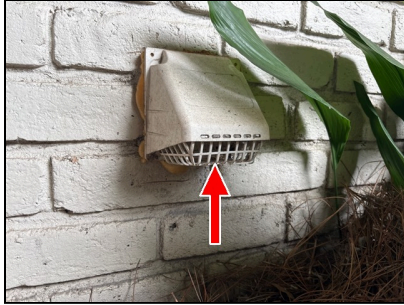
3.1 Item 2(Picture)

(2) It is not recommended to have a screen at the bottom of the dryer vent. The screen will collect lint. Repair as needed.

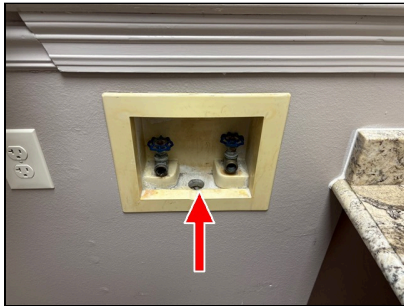
3.1 Item 3(Picture)

(3) The drain line for the washing machine is 1 1/2" piping. This size piping was widely used during the time of construction of this dwelling, today's standards call for 2" piping on the washing machine drain line. The water pressure when the washing machine pumps out will sometimes cause the 1 1/2" drain piping to back up. There are no visible signs of this happening but this should be monitored.

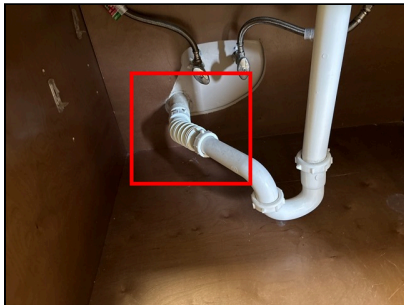
3.2 Item 1(Picture)

There is corrugated piping used at the sink waste drain lines at the kitchen. This style of piping is prone to clogging faster than smooth bore piping. Repair as needed.

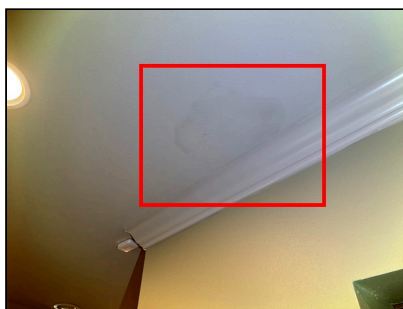
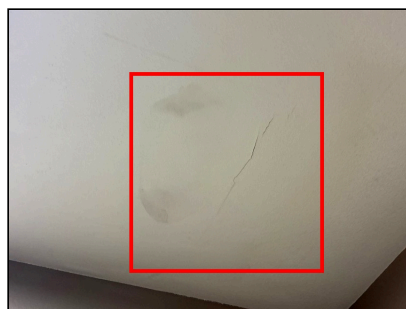
(3) The ceiling is stained in one or more places. It appears that the staining is old. Monitor for further staining and repair as needed.

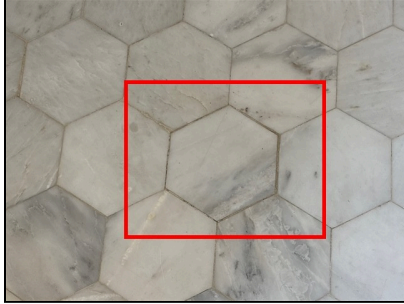
4.2 Item 1(Picture)

(1) One or more floor tiles are loose. Repair as needed.

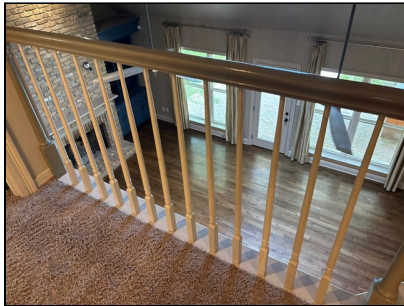
4.4 Item 1(Picture)

The spindles on the railings are too far apart which could allow a child to get their head through and get caught or fall through. In older construction it was allowed to have the spindles over 4" apart, today's standards suggest the spindles be 4" or less apart. The handrail at the top of the stair is loose. Repair as needed.

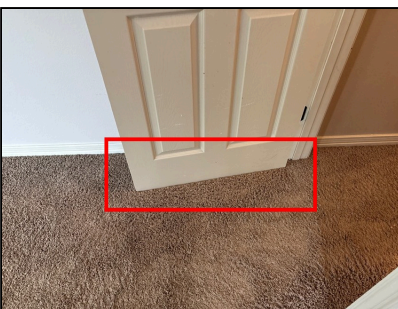
4.5 Item 2(Picture)

One or more interior doors are too close to the floor when closed and will not allow return air flow under the doors. An entry door to a room with an HVAC vent should have 1/2" to 3/4" inch of clearance under the door. Repair as needed.

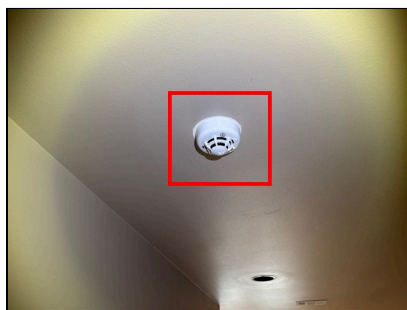
4.6 Item 1(Picture)

(1) There are one or more smoke detectors installed on the alarm system that could not be checked. **I suggest checking these before occupancy to insure that they are working properly.**

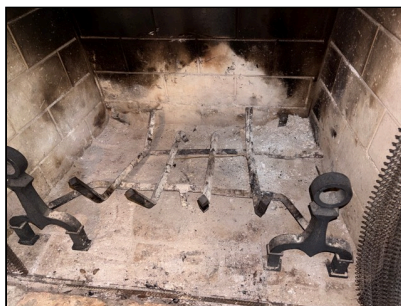
4.9 Item 2(Picture)

All fireplaces should be cleaned and inspected on a regular basis to make sure that no cracks have developed. Large fires in the firebox can overheat the firebox and flue liners, sometimes resulting in internal damage. Before the beginning of the wood burning season, all fireplace flues and flue lining should be inspected by a chimney professional. Fireplace flues and linings are not fully visible and are not included in the scope of this inspection. For safety we recommend installing a CO detector no closer than 15 feet from the fireplace. The ash needs to be cleaned out of the bottom of the firebox.

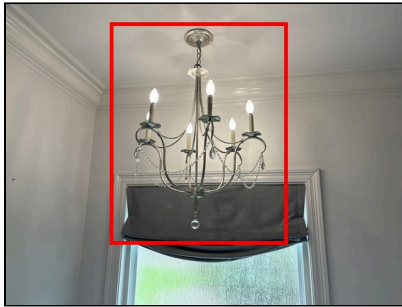
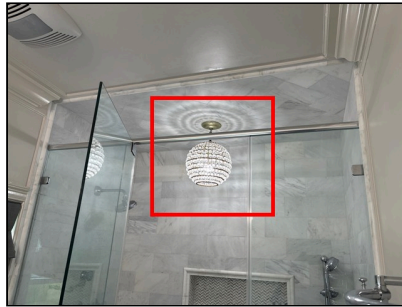
(1) By today's standards, hanging chandeliers cannot be within 8 feet of the top rim of the tub or in a shower. **I recommend removing these fixtures and replacing within enclosed wet rated lighting.** Repair as needed.

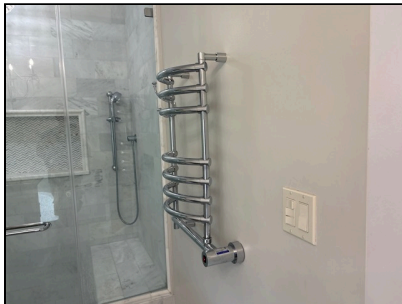
5.3.A Item 3(Picture)

(2) The built-in towel warmer did not work. Repair as needed.

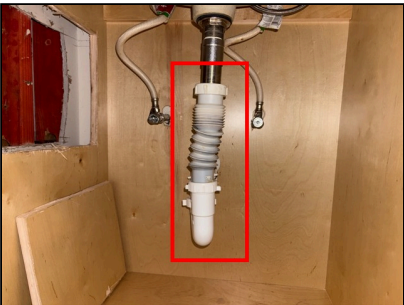
5.1.B Item 2(Picture)

There is corrugated piping used at the sink waste drain lines at the hall bath. This style of piping is prone to clogging faster than smooth bore piping. Repair as needed.

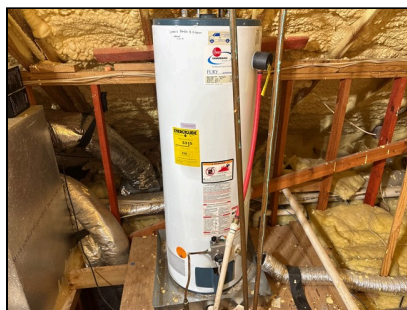
7.2 Item 3(Picture)

(3) Flushing the water heater tank every year prevents sediment from building up and helps ensure that your heater can continue working effectively . A licensed plumbing professional can flush the heater, if you would like to know what this involves I have included a link to an instruction video for your convenience.

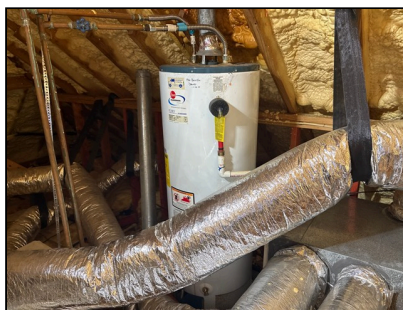
7.2 Item 4(Picture)

(2) There were signs of a past leak at the left side water heater. No leaks were observed at the time of inspection. Repair as needed.

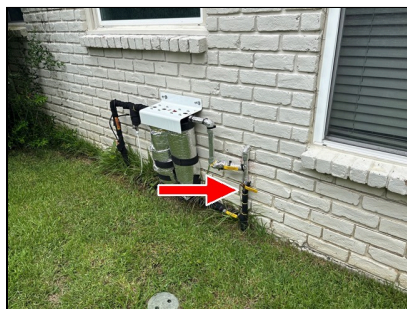
7.3 Item 1(Picture)

The main water shutoff valve is located on the left side of the home. Water filtration systems are not part of a standard home inspection. This is for your information.

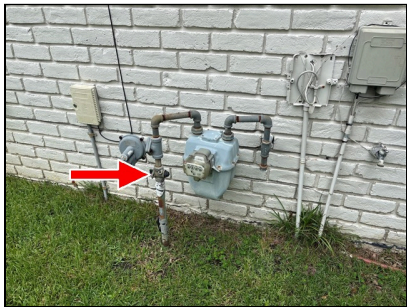
7.4 Item 1(Picture)

The gas meter and main fuel shut off valve are located on the left hand side of the home. This is for your information.

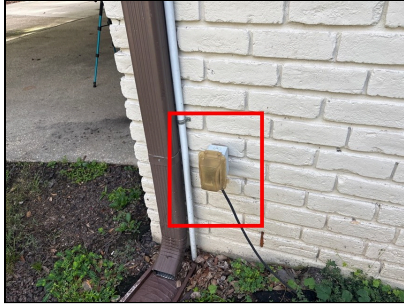
8.0 Item 1(Picture)

🔧 (1) The exterior receptacle at the back of the carport is not secured to the wall. **Repair is needed.**

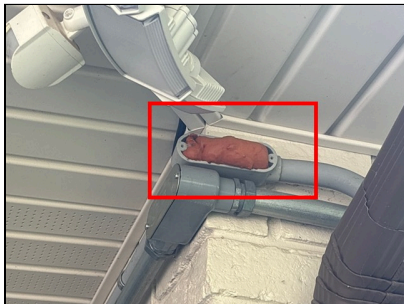
8.0 Item 3(Picture)

(3) The LB junction in the conduit at the rear corner of the carport is missing a cover. Repair as needed.

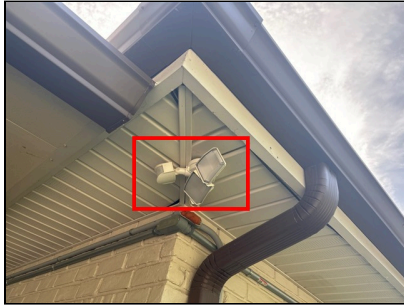
8.0 Item 4(Picture)

(4) Exterior lighting on daylight/motion sensors could not be tested.

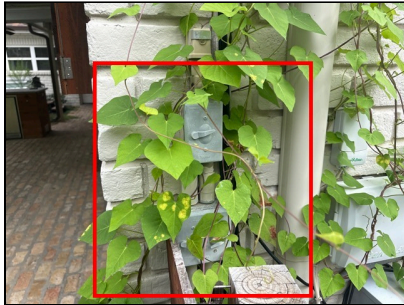
8.0 Item 5(Picture)

(5) I could not determine the purpose of the light switches on the left rear corner of the home.

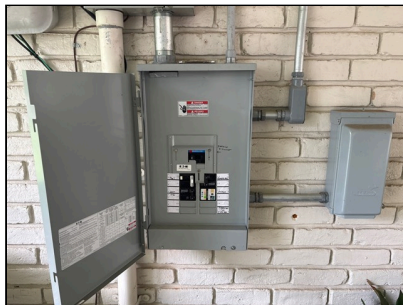
8.1 Item 2(Picture)

⚡ (1) The problem(s) discovered in the exterior main panel such as no dielectric grease on the aluminum wiring terminations, and any other problems that an electrician may discover while performing repairs need correcting. I recommend a licensed electrician inspect further and correct as needed.

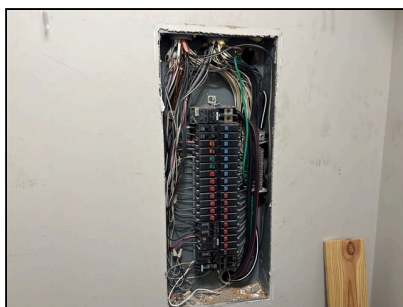
8.1 Item 6(Picture)

⚡ (2) The problems discovered in the panel such as circuits not labeled or identified, missing and/or wrong screws in panel cover, no dielectric grease on the aluminum wiring terminations, and any other problems that an electrician may discover while performing repairs need correcting. **I recommend a licensed electrician inspect further and correct as needed.**

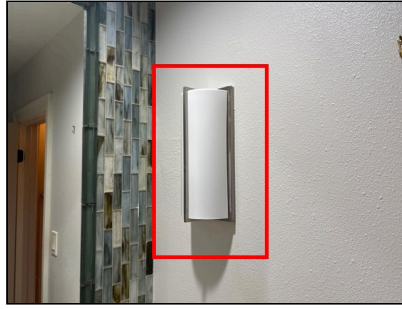
8.2 Item 2(Picture)

One or more light fixtures do not work. Check the bulbs. Repair as needed.

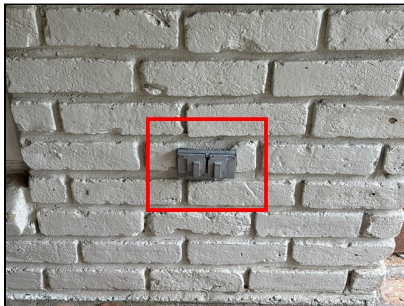
8.3 Item 2(Picture)

(2) GFCI receptacles may or may not have been required within 6' of water when this home was constructed, but it was noted that there are none in one or more places at the exterior. **I suggest the client have GFCI receptacles installed for safety.**

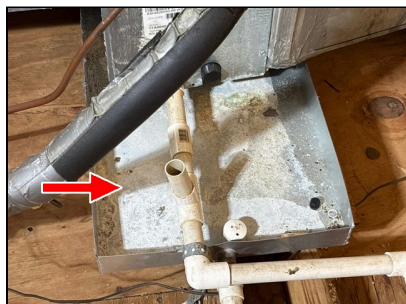
9.0.A Item 2(Picture)

(3) There is rust/corrosion in the evaporator coil overflow pan indicating a past problem, the pan is currently dry. I could not determine if the pan is rusted/corroded through.

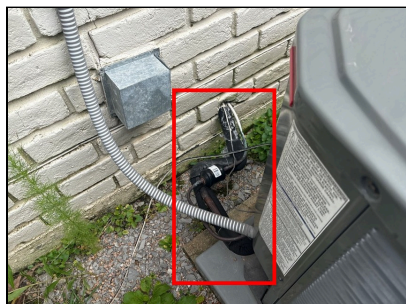
9.0.A Item 3(Picture)

(4) The suction line on the outside condensing unit is missing insulation which will cause the line to drip condensate and cause energy loss. Repair as needed.

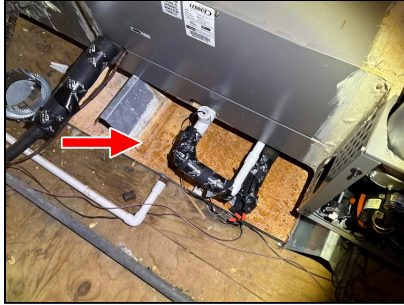
9.0.B Item 2(Picture)

(3) There is rust/corrosion in the evaporator coil overflow pan indicating a past problem, the pan is currently dry. I could not determine if the pan is rusted/corroded through.

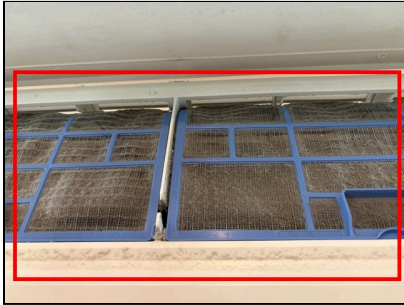
9.4.C Item 1(Picture)

The return air filter is dirty and **requires cleaning**.

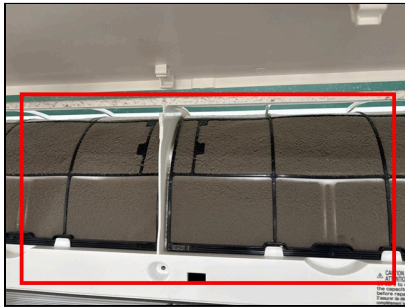
9.4.D Item 1(Picture)

The return air filter is dirty and **requires cleaning**.

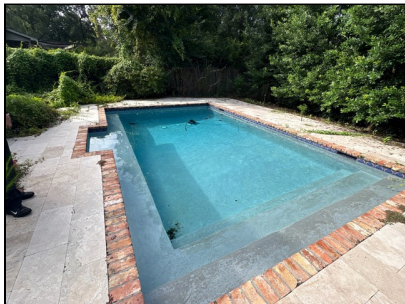
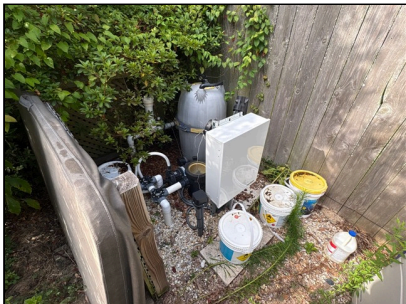
The pool was clean and operating at the time of this inspection.

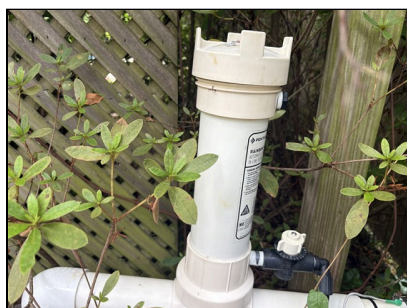
12.3 Item 1(Picture)

(2) There is a Pentair Rainbow Model 320 Chlorine/Bromine In-Line Feeder installed on the system. More information on this feeder can be found by copying and pasting this link to your browser:

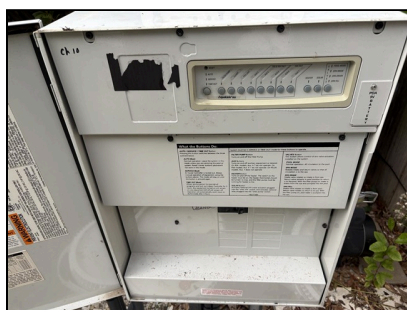
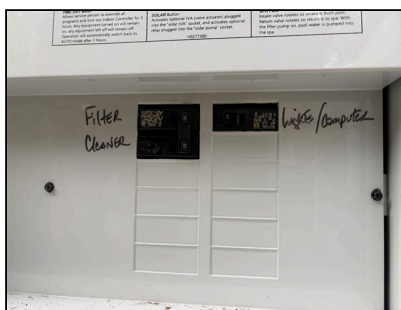
(3) There is a Jandy Aqualink RS Power Center installed on the pool. The remote for this system was on the counter at the outdoor kitchen but the batteries were dead. More information on this control panel can be found by copying and pasting this link to your browser:

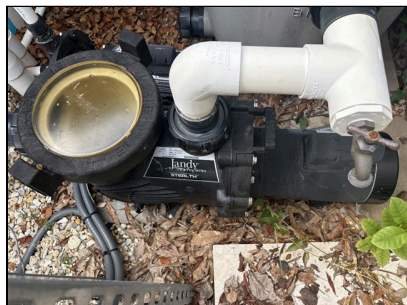
12.4 Item 1(Picture)

The Jandy Pro Series Stealth circulation pump was manufactured in September of 2019. More information on this pump can be found by copying and pasting this link to your browser:

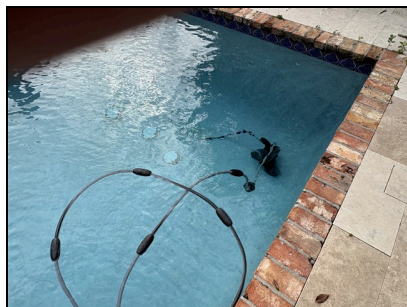
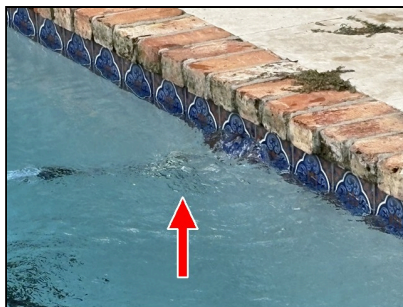
(2) The Polaris vacuum was operating at the time of this inspection but was moving slowly. The backup valve at the hose connection near the wall may need adjusting.

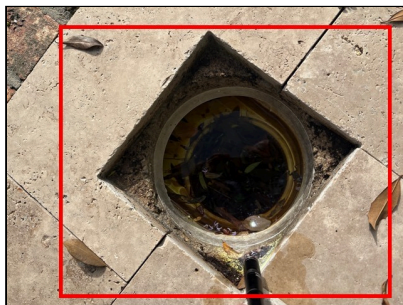
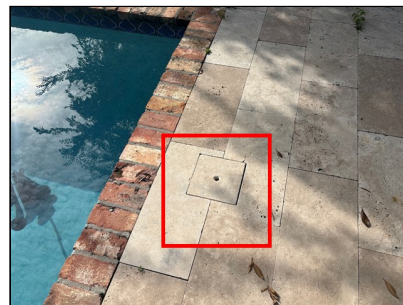
(1) There are two overflow skimmers at the rear of the pool. Both skimmer baskets were full of debris and were missing the lift handles. Repair as needed.

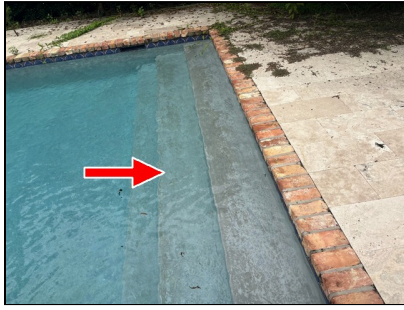
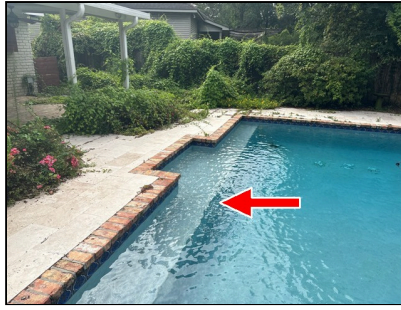
There are steps without handrails at the shallow end and an egress ledge near the deep end of the pool.

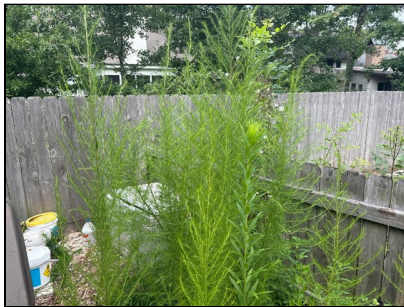
12.15 Item 1(Picture)

The rear yard is enclosed by 6 foot and 4 foot wood fencing. There is no separate security fencing around the pool.

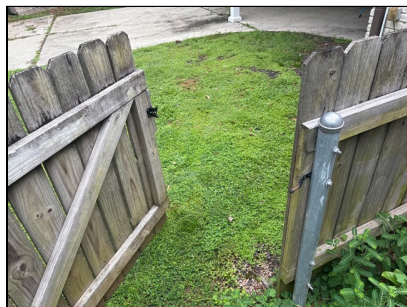
12.16 Item 1(Picture)

The 4 foot walk gate is not self closing and does not have a locking mechanism. This may allow for unsecured public access to the pool area. Repair as needed.

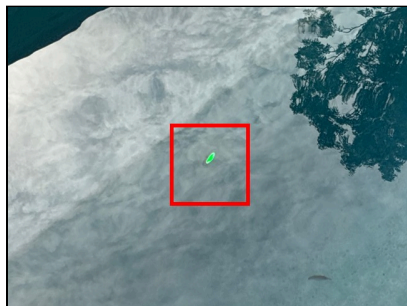
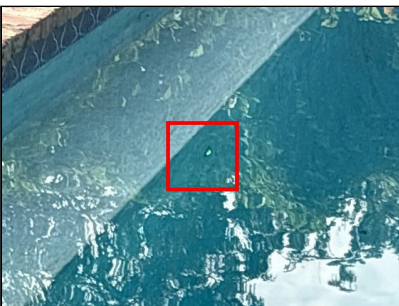
The LED pool lighting was working at the time of this inspection.

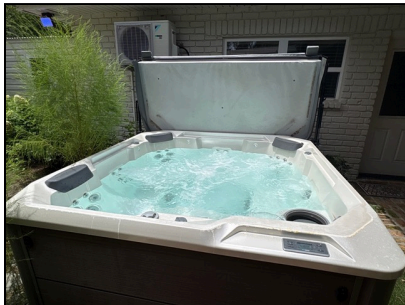
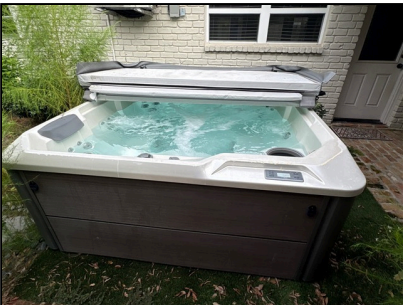
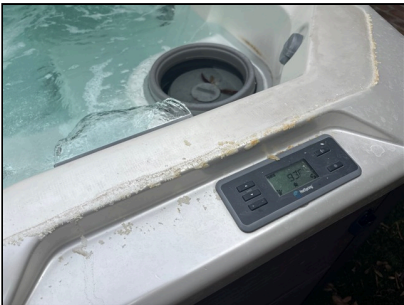
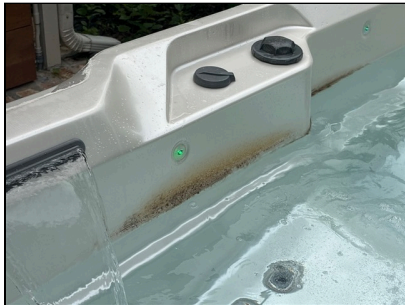
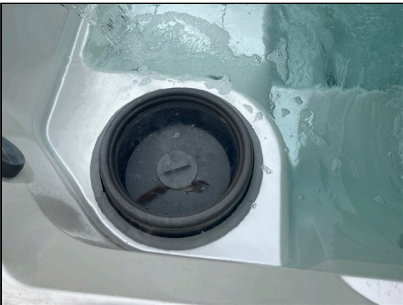
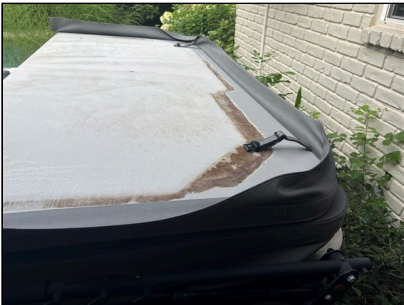
The hot tub was operational at the time of this inspection. The unit has not been used recently and needs cleaning. Areas of the cover and seat padding are damaged from prolonged contact. The hot tub is wired to a 50AMP GFCI protected circuit.
